## **Transport of passive admixture in a multi-channel river system - the Upper Narew case study. Part 1. Hydrological survey**

### **Abstract**

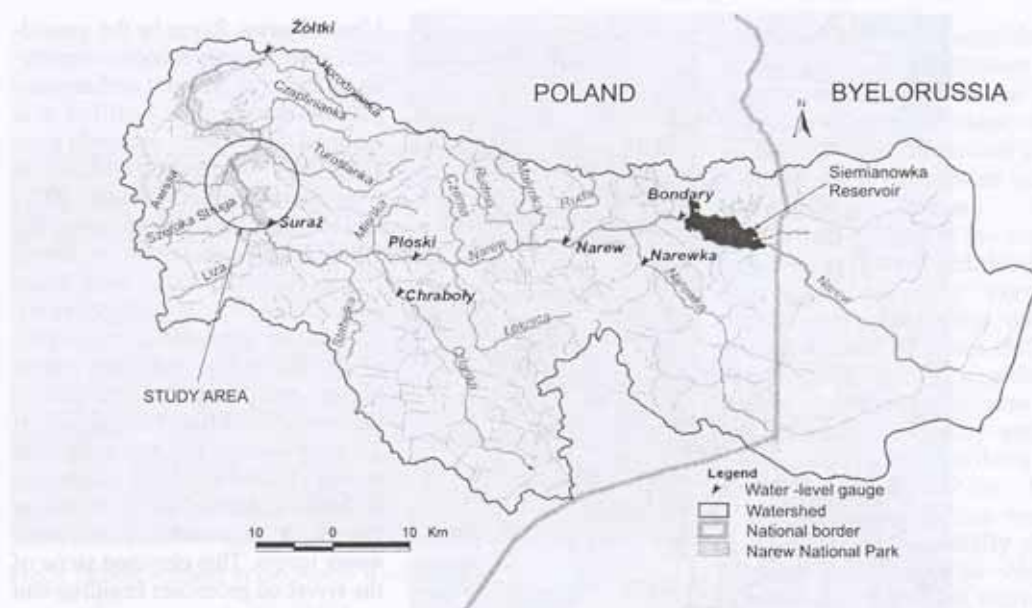
Fig.1. The Upper Narew River catchment (modified from Rowiński, Napiórkowski 2001).

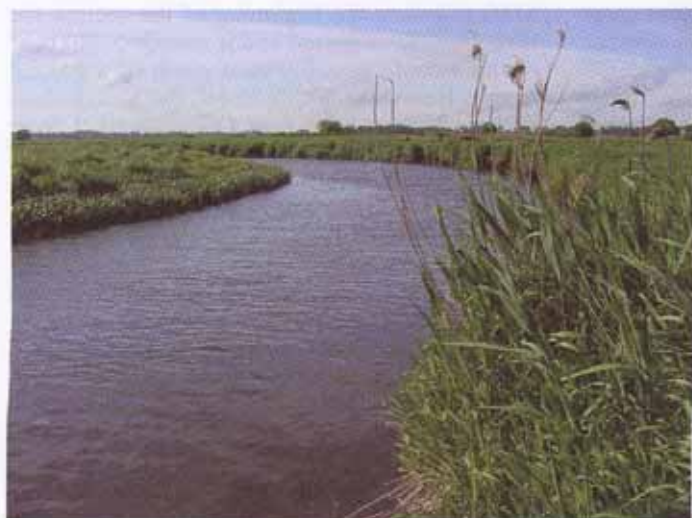
Fig.3. Typical bending in the Narew River.

The Upper Narew River in the considered meridional part is of an anastomosing type. The Narew channel meanders (Fig. 3) and it influences the dynamics of water flow. The onset of flow deflects some of the water towards the channels sides. As it reaches the side of the channel it is reflected back toward the opposite side of the channel. As the water changes side, it obviously also flows downstream, resulting in a zigzag flow line pattern. Meanders are an essential large-scale feature of river topography. The ratio of the length of the main riverbed to the length of the valley (the sinuosity index) is 1.4 which depending on different sources classifies the Narew River in this section as a meandering or sinuous river (Hersch, Fairbridge 1998; Yalin 1992). It is worth to note that the sinuosity index obtained by Gradziński *et al.* (2000) in respect to the further section of the Narew River was less than 1.3. Anyway, the statement that the planform of the

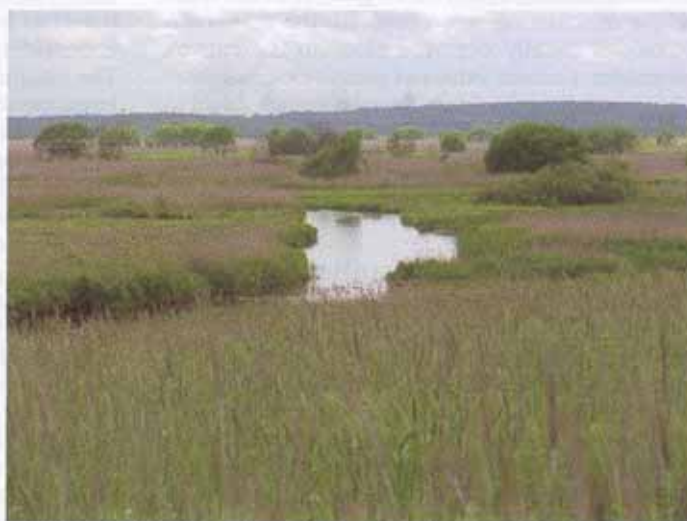
Fig.4. Napiórka - shallow branch of the Narew River.

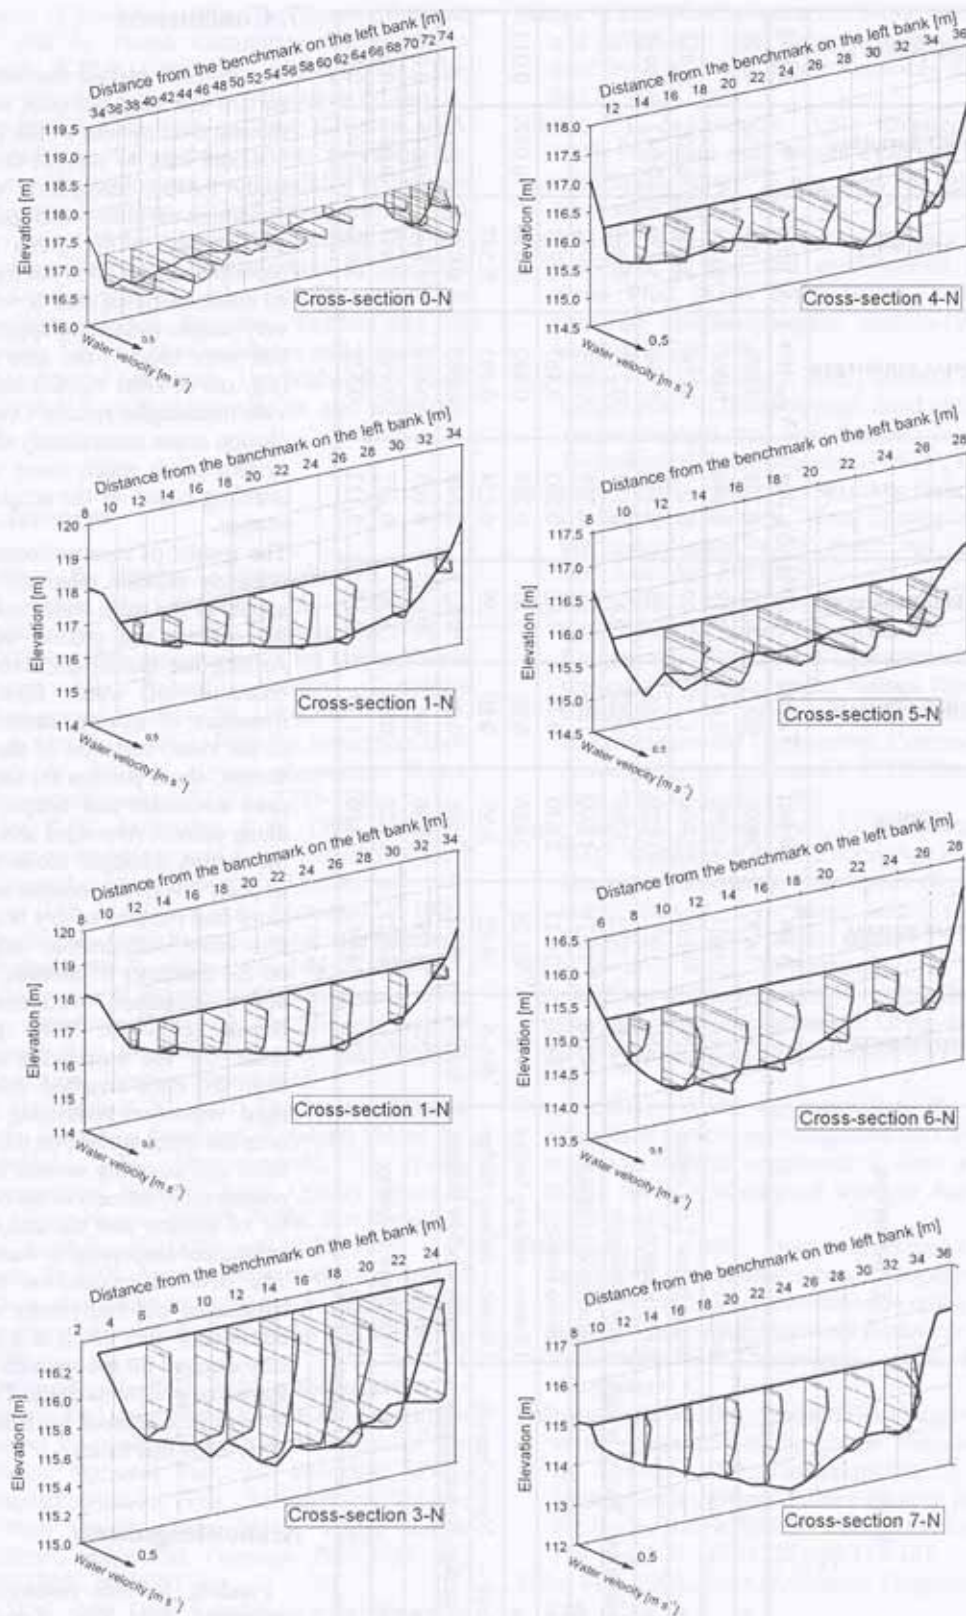
Fig.5. Streamwise velocity distributions at the selected verticals of each cross-section under consideration.

Point velocity distributions at the selected verticals of each cross-section under consideration are shown in Fig. 5. Usually they are in agreement with classical vertical velocity distributions with maximum values occurring in the range between the level  $0.8H$  and the water surface. Only in a few cases the vertical velocity distribution was disturbed (e.g. vertical I at the cross-section "1"). Note that the maximum streamwise velocities did not occur at utmost verticals located close to the riverbanks. The reason is that the measuring cross-sections were selected at possibly straight river reaches in which the parallelity of water streams occurred. In general in the areas where meandering was observed, the maximum velocities usually occurred close to the convex riversides. Greater values of point velocities were observed below the Szolajdzianka branch down to the profile "6-N". The highest mean and maximum velocity were measured at the cross-section "5-N".
